<b>ALSAN RS WATERPROOFING MEMBRANE MINOR MOVING (1mm or Less) CRACK REPAIR</b>			
REVISION	ISSUE DATE	SCALE	DRAWN BY
0	12-15-2018	N.T.S.	DRW

DRAWING NO.:  
**RS-J1B**

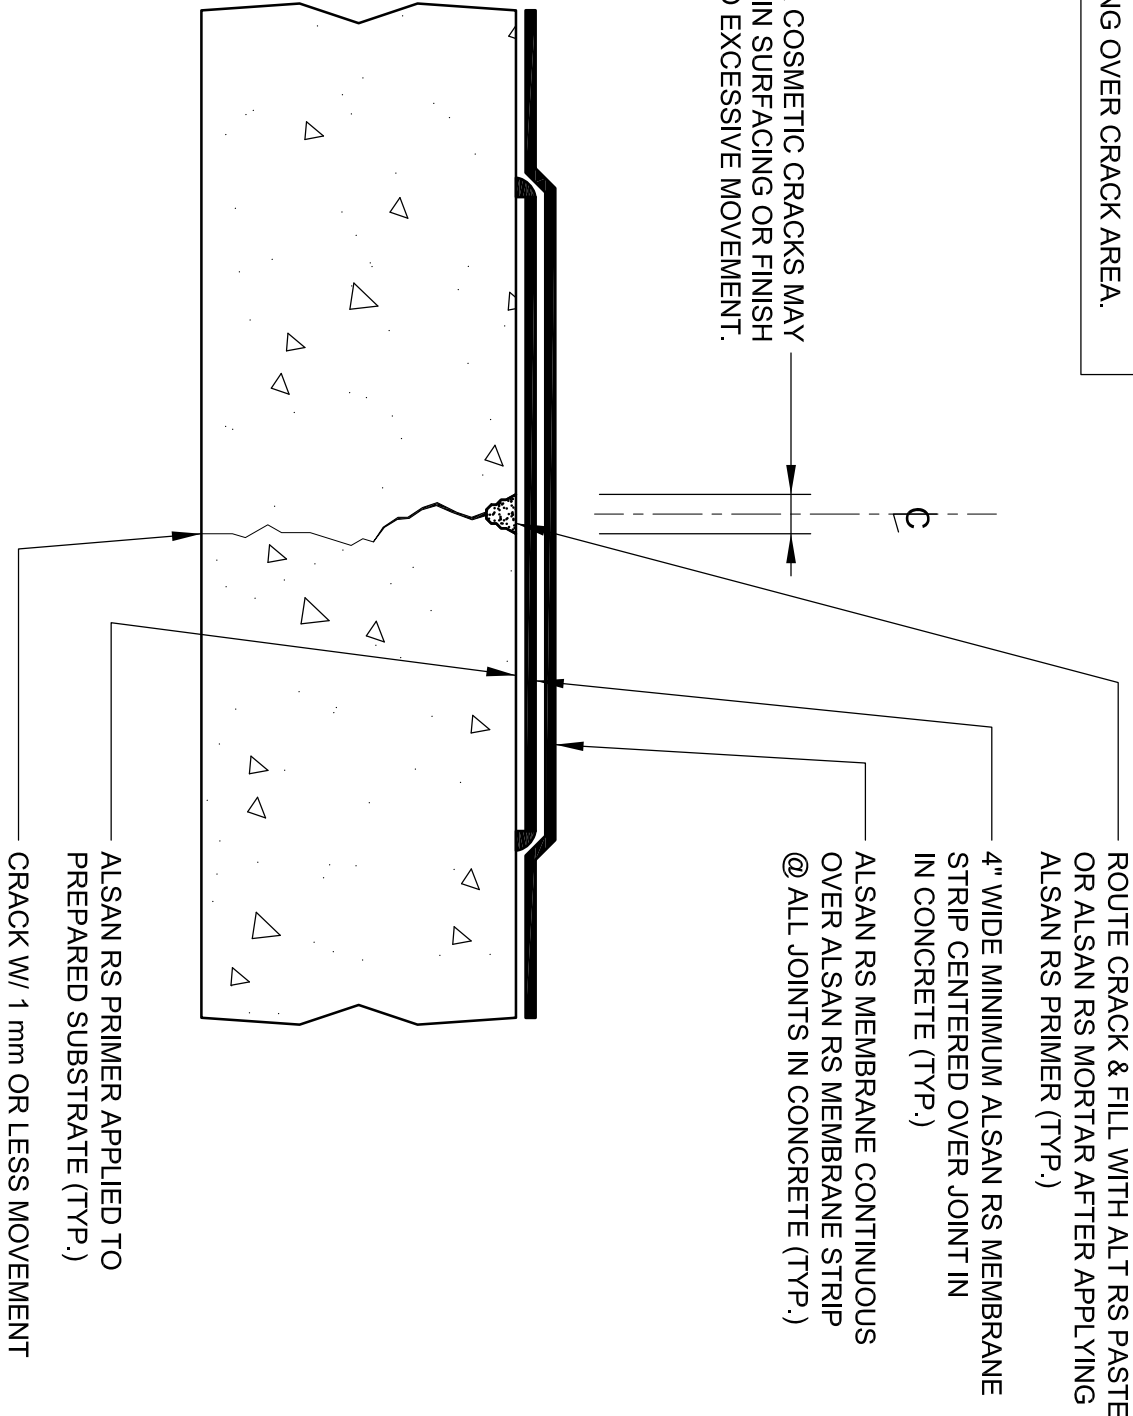
**NOTE:**  
 THIS DETAIL SHOULD BE USED FOR MINOR  
 CRACKS HAVING 1mm OR LESS MOVEMENT.  
 MOVEMENT MAY CAUSE MINOR COSMETIC  
 CRACKS AN/OR CRAZING IN FINISH TOPCOAT  
 AND/OR SURFACING OVER CRACK AREA.

MINOR COSMETIC CRACKS MAY  
 OCCUR IN SURFACING OR FINISH  
 DUE TO EXCESSIVE MOVEMENT.

ROUTE CRACK & FILL WITH ALT RS PASTE  
 OR ALSAN RS MORTAR AFTER APPLYING  
 ALSAN RS PRIMER (TYP.)

4" WIDE MINIMUM ALSAN RS MEMBRANE  
 STRIP CENTERED OVER JOINT IN  
 IN CONCRETE (TYP.)

ALSAN RS MEMBRANE CONTINUOUS  
 OVER ALSAN RS MEMBRANE STRIP  
 @ ALL JOINTS IN CONCRETE (TYP.)

ALSAN RS PRIMER APPLIED TO  
 PREPARED SUBSTRATE (TYP.)

CRACK W/ 1 mm OR LESS MOVEMENT
